Greenery of the Sacral Monuments – Unique Green Infrastructure in the Urban Area: Case Study Calvary in the Nitra

Greenery of the sacral monuments – unique green infrastructure in the urban area: case study Calvary in the Nitra

The article has aim to point on the importance, potential and limits of the greenery near the sacral objects. The model territory is the Calvary in Nitra city. Based on landscape-architectonical analyses and dendrology assessment were set landscape principles for suitable restoration of the functions and greenery of the Calvary.

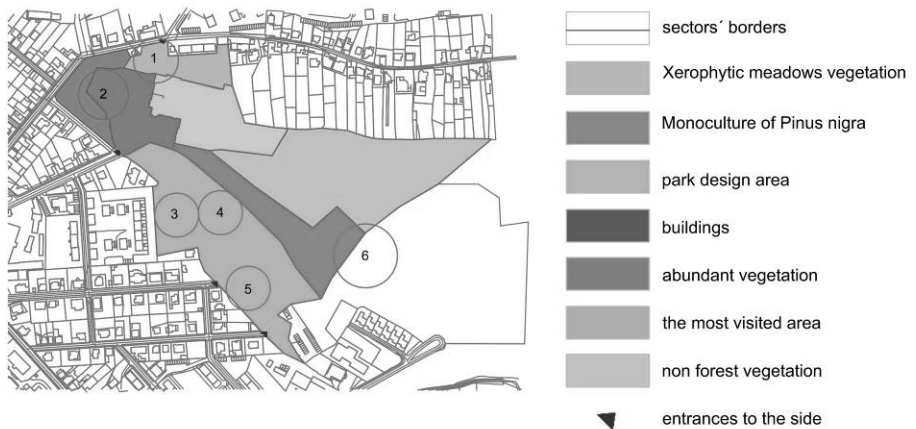
Figure 3. Category of the greenery and concept of the side

1 educational trail leads to the Cave of Holy Mary; 2 park design supported by flower beds, trees and with the protection of the views to the city; 3 Children playground designed by simply wooden elements; 4 Fire place and open meadow; 5 Sport/Fit trail; 6 Climbing rock

The landscape concept “*Living in the wood*” was chosen as the suitable proposal for revitalisation of the site. We have proposed 3 main zones: 1. *Representative entrance zone*, 2. *Zone of leisure and recreation*, 3. *Sport zone*.

The first zone will be equipped with more benches to sit, places to stop and learn some historical facts and remarkableness of the side through the educational boards, to perceive the surroundings and views, there will be added flower beds and new plantation of the greenery.

Recreational and leisure zone will be designed as a place for the families with different activities: playgrounds, fire place, benches, and new plantation of the *Rhododendron* sp.

Sport zone offers facilities for sport, recreation, fitness activities. In this part it is necessary to make thinning and new plantation of the trees from the compositional point of view.
